# Manhole Inspection Summary

## Manhole # S33SS\_104MH

Insp Date: **10/29/08 11:10 AM**

**Location** Address: **2721 MARYLAND AVE**

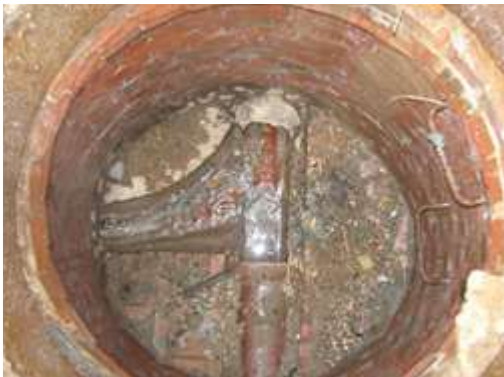
Top View

Corroded steps. Evidence of surcharge - Bench debris.

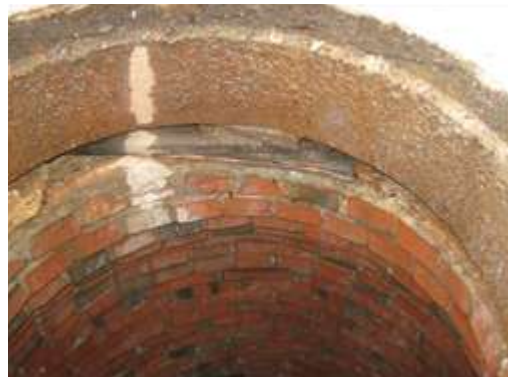
Defect

☒ **Leaks**

Condition: ☐ Sound ☐ Cracked ☐ Root Intrusion ☐ Loose Brick ☒ **Deteriorated**

Infiltration: ☐ None ☒ **Joint** ☐ Cracks ☐ Mortar ☐ Roots ☒ **Wall**

Frame leaks. Adjustment deterioration and infiltration. Corbel and Barrel infiltration.

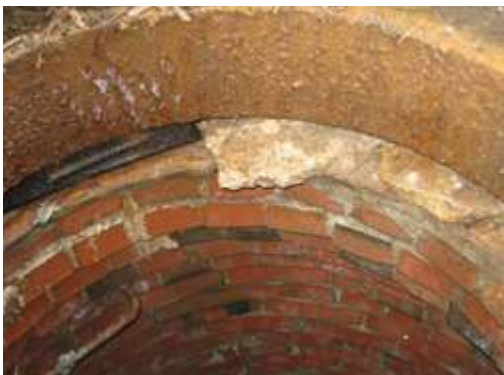
Defect

Frame leaks. Adjustment deterioration and infiltration. Corbel and Barrel infiltration.

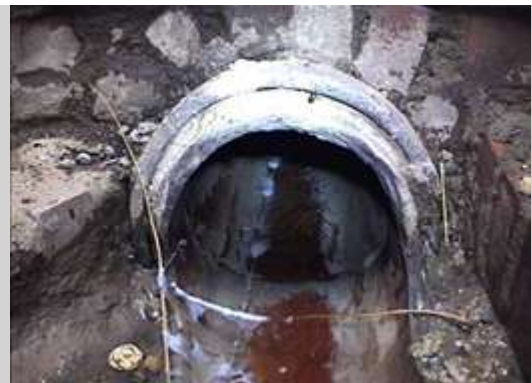
Pipe Out @ 12 O'Clock

Infiltration: **Evidence** Pipe Seal Cond: **Unknown**

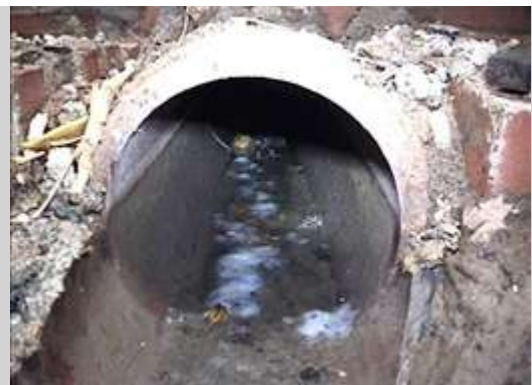
Pipe In @ 3 O'Clock

Deposits: ☐ None ☒ **Mud** ☐ Sludge ☒ **Debris** ☐ Grease

Silt Depth: **0.5** (in.) Deposits Extent: **Light**
